## **Summary of EPA Surface Water Sampling Results to Date**

### **Gold King Mine Blowout**

Updated August 7, 2015

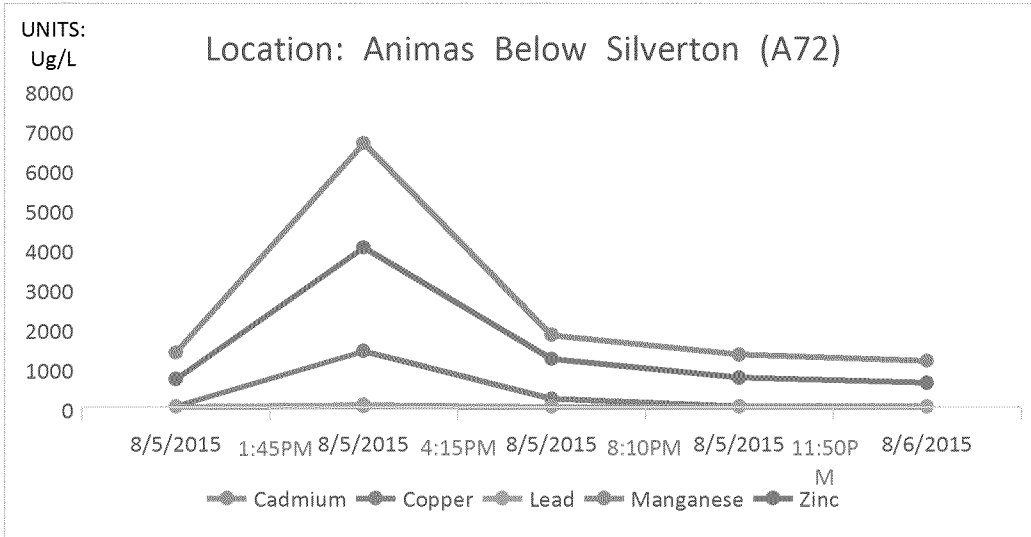
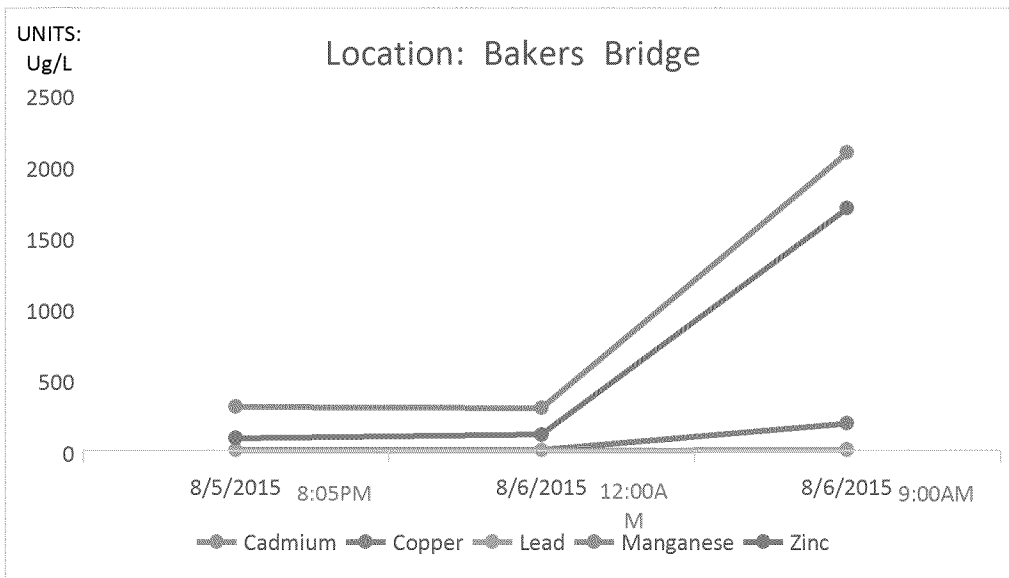
## Attachment 2: Trends

The samples were analyzed for dissolved phase metals. Cadmium, copper, lead, manganese and zinc were selected for summary in this report because historical data from the Gold King Mine indicates that these metals are good indicators of potential impacts to ecological and human health at this site. The data shows that concentrations of metals increased as the plume moved downstream and that these concentrations decreased towards baseline conditions.

EPA will continue to collect monitoring data and expects subsequent sampling events to show decreasing concentrations of contaminants as the tailing edge of the plume moves downstream.
